Rain Erosion Testing of Lightning Diverters

Report Date: 14 January 2011

Revision 2

For Shine Wire Products, Inc.

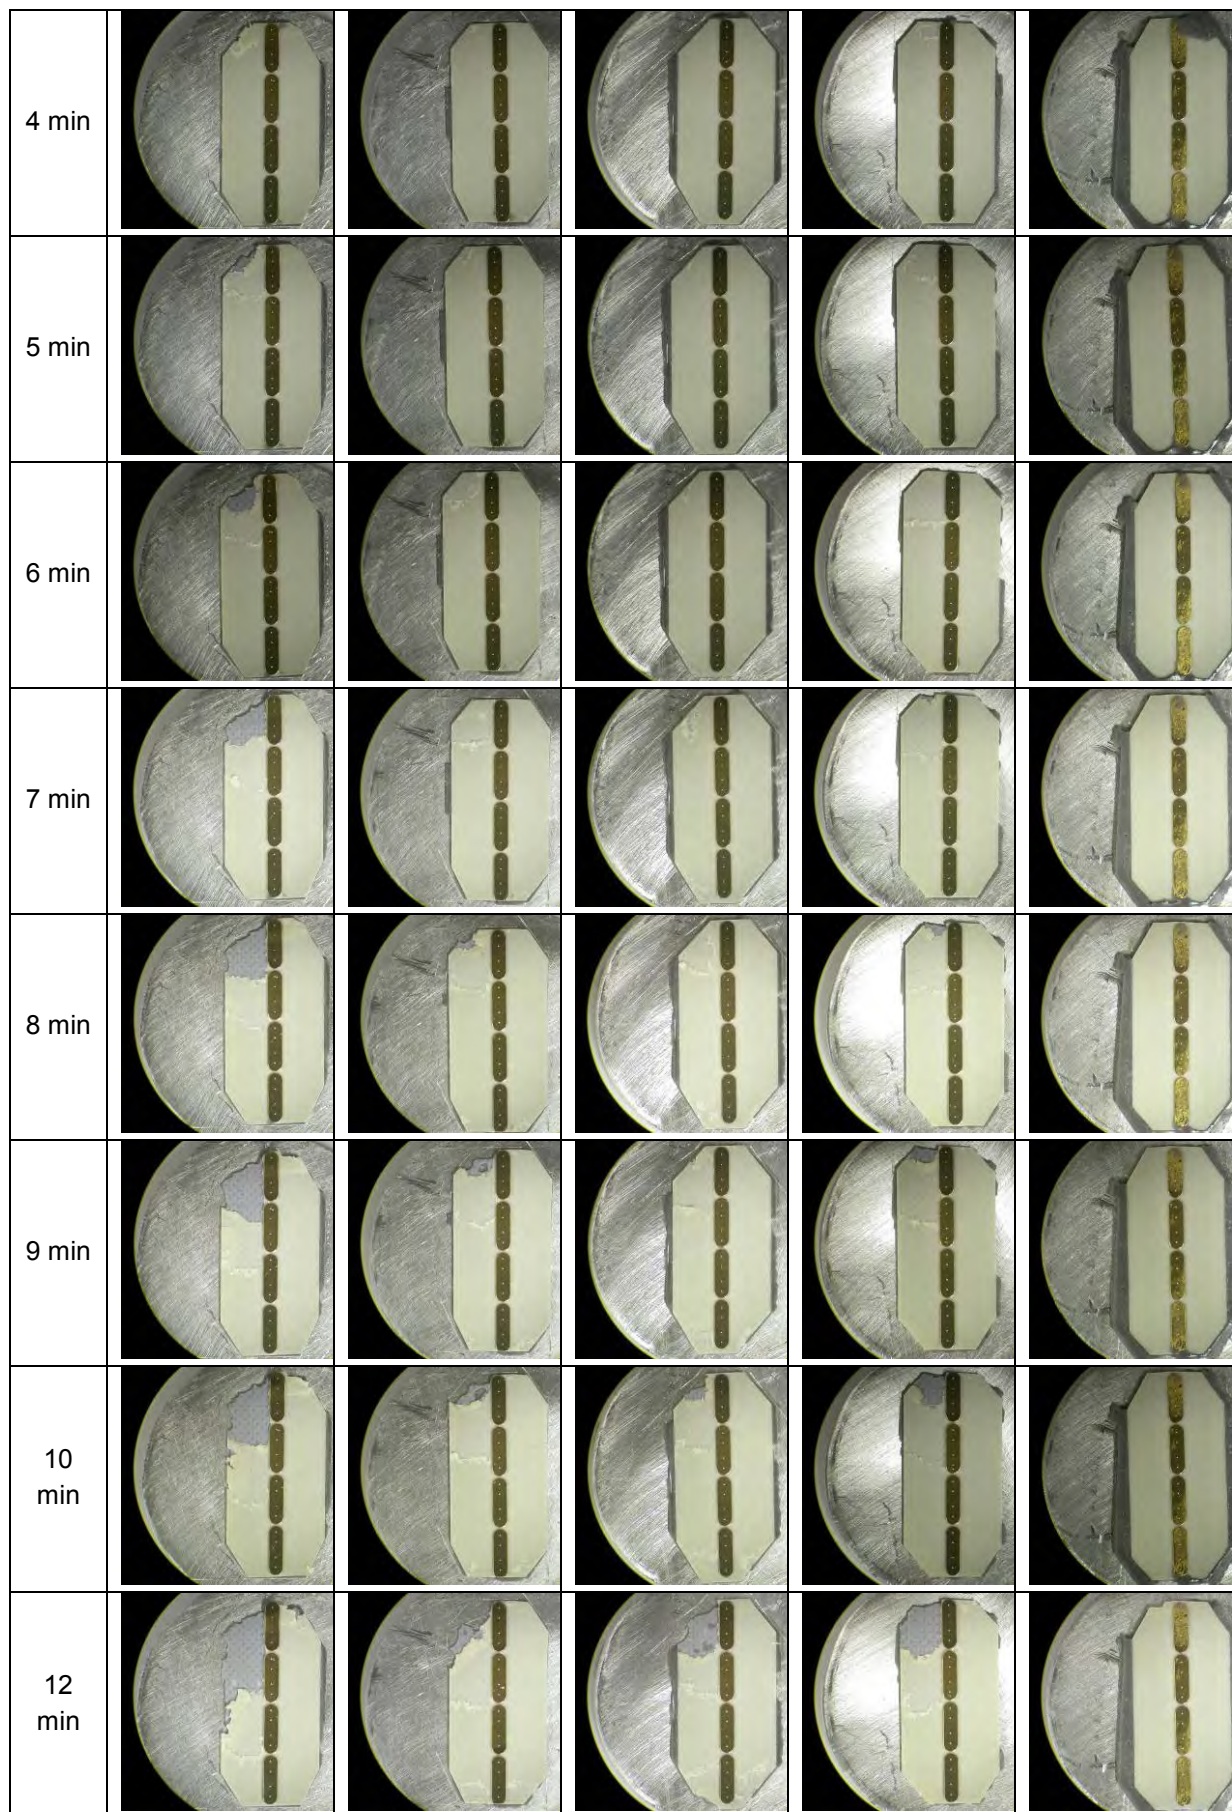
4.1 Test results: specimens W1-5

The results of the above tests clearly show that the rain erosion resistance of the WXGuard specimens, W1-W5, is far superior to that of the competitor's specimens, L1-L5. The WXGuard specimens were seen to last 4 times longer in the simulated rainfall environment. The criteria used to indicate the end of the test was the removal of the lightning diverter buttons. It can be seen that 3 of the 5 competitor's specimens did not last beyond 3 minutes. Buttons were seen to be missing after 4 minutes testing in 4 of the 5 specimens. In comparison, WXGuard specimens lasted until 18 minutes intact. Four of the five specimens had failed after 20 minutes of testing.

The WXGuard specimens W1-W5 showed a greater resistance to the droplet impact. These specimens tended to all fail in a similar way. The upper left corner of the specimens was the initiation site for the erosion of the laminate. The first layer was

then removed with the base layer proving harder to remove. The gold plated buttons were only removed when a large amount of the underlying laminate had been eroded. Specimen W5 showed little or no signs of damage and erosion initially but once the adhesive around the periphery was eroded, the laminated failed at a higher rate than the other specimens. It failed in the same time period as the other specimens, leaving an inconclusive result as to whether the extra adhesive would extend the in-service life of the specimen, as was shown with the L5 specimen.
